This document contains **sample excerpts** of the type of information and color photographs provided in a typical Cornerstone Home Inspections report.

THIS IS NOT A FULL REPORT.

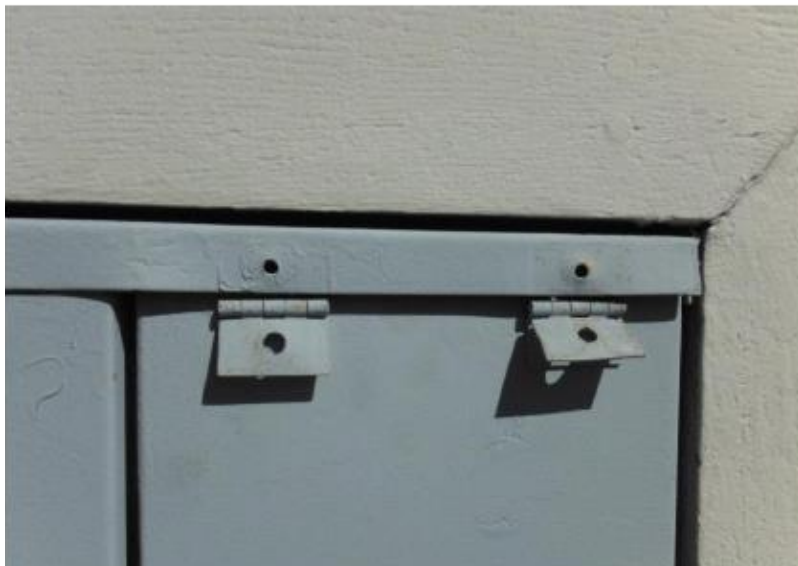
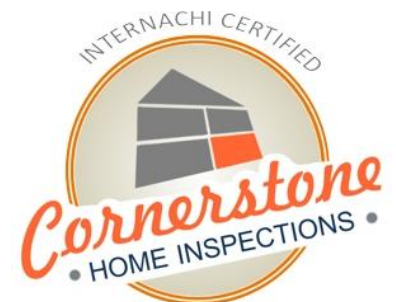
- 711 MAIN PANEL

[CR] The cover hinges were missing/damaged. We recommend correcting the condition noted.

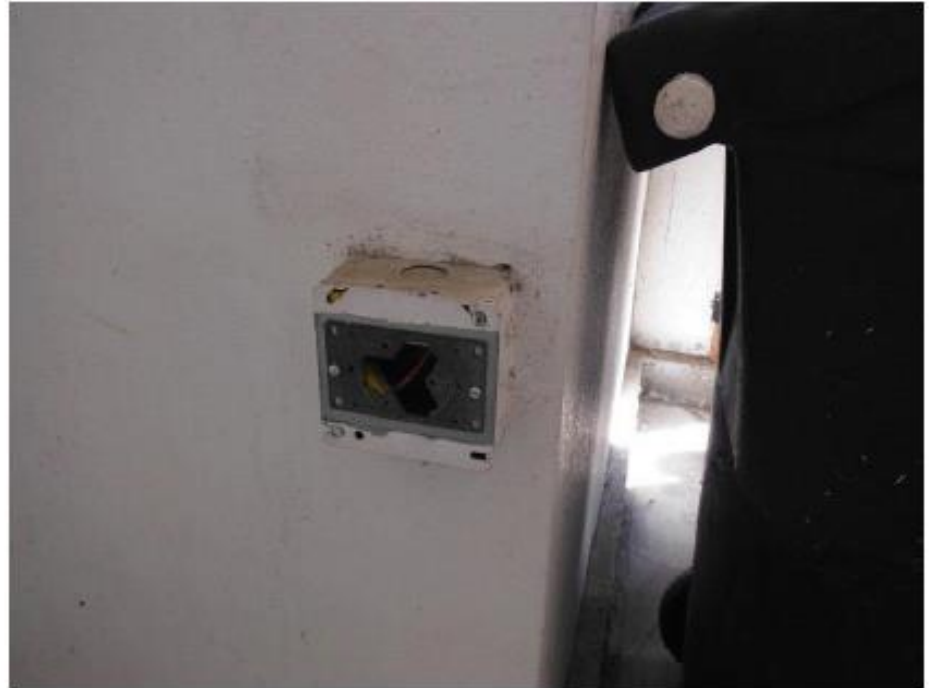
723 *BRANCH WIRING*

[SC] There was an electrical junction box in the garage with no cover. We recommend correcting the condition noted.

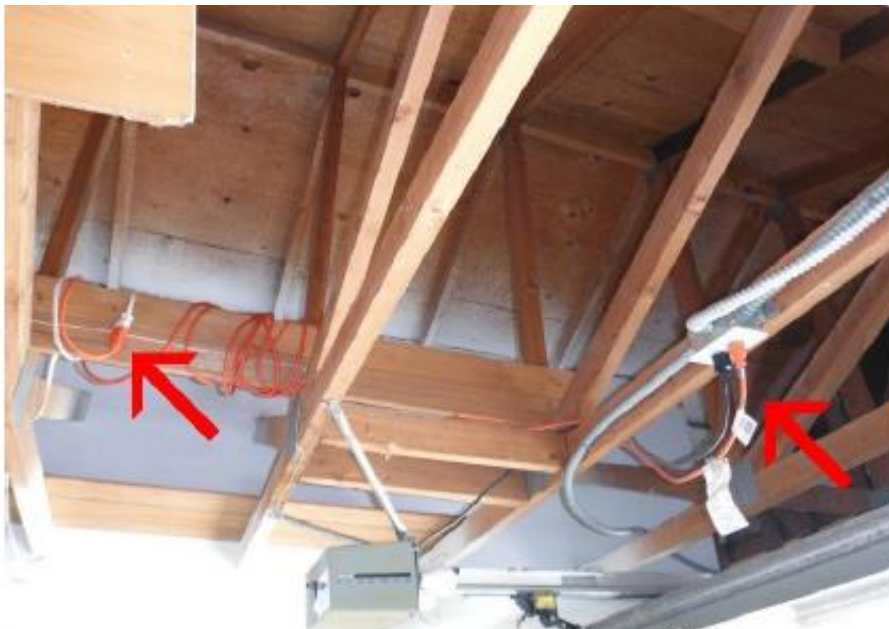
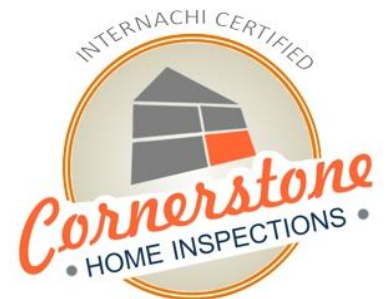
728 *LIGHT(S)/FIXTURE(S)*

[SC] Power was supplied to the garage light fixture via an extension cord. This condition is a safety hazard. We recommend correcting the condition noted.

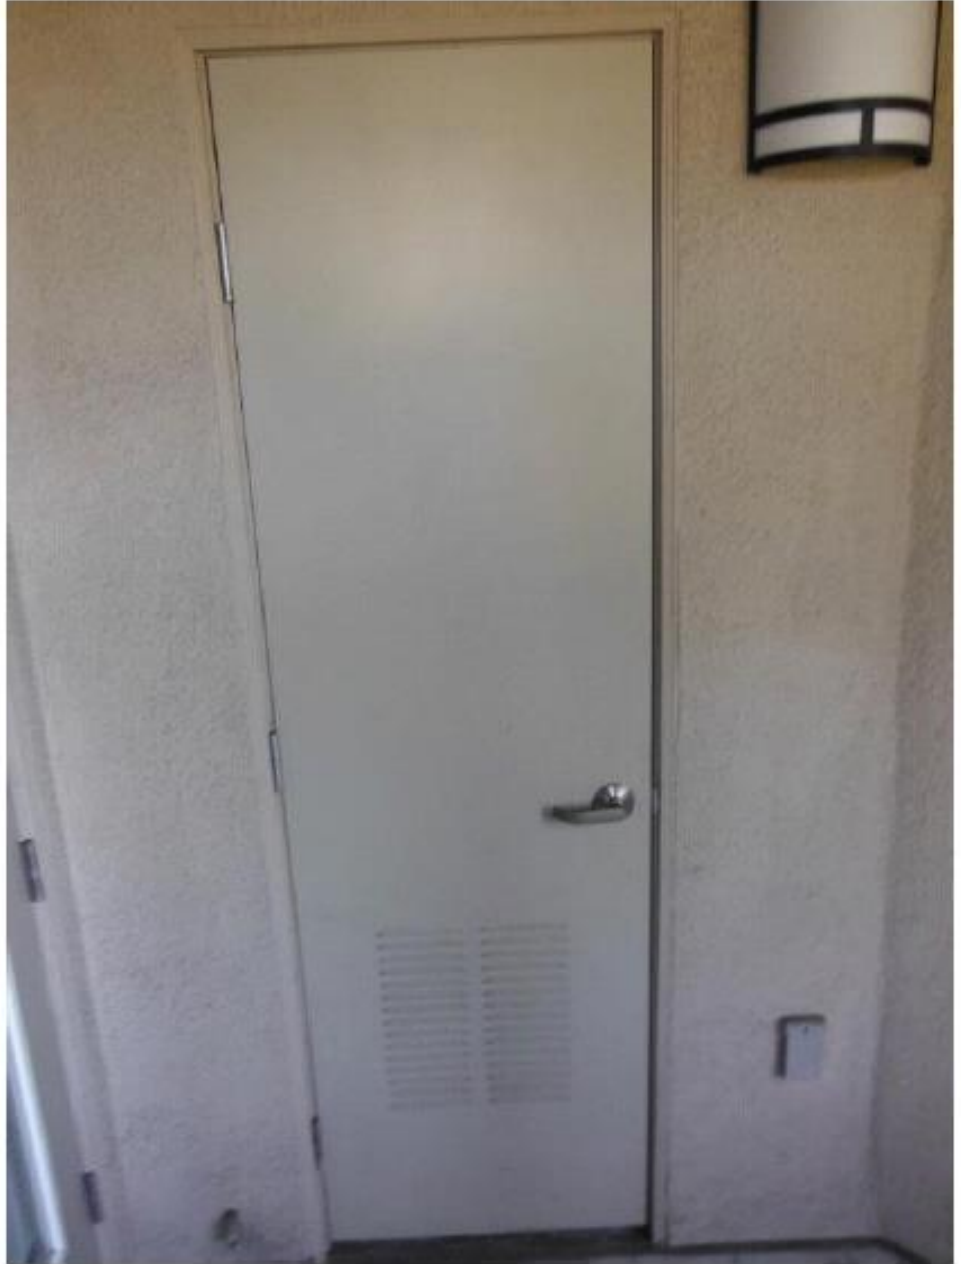
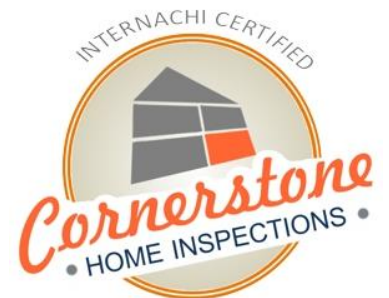
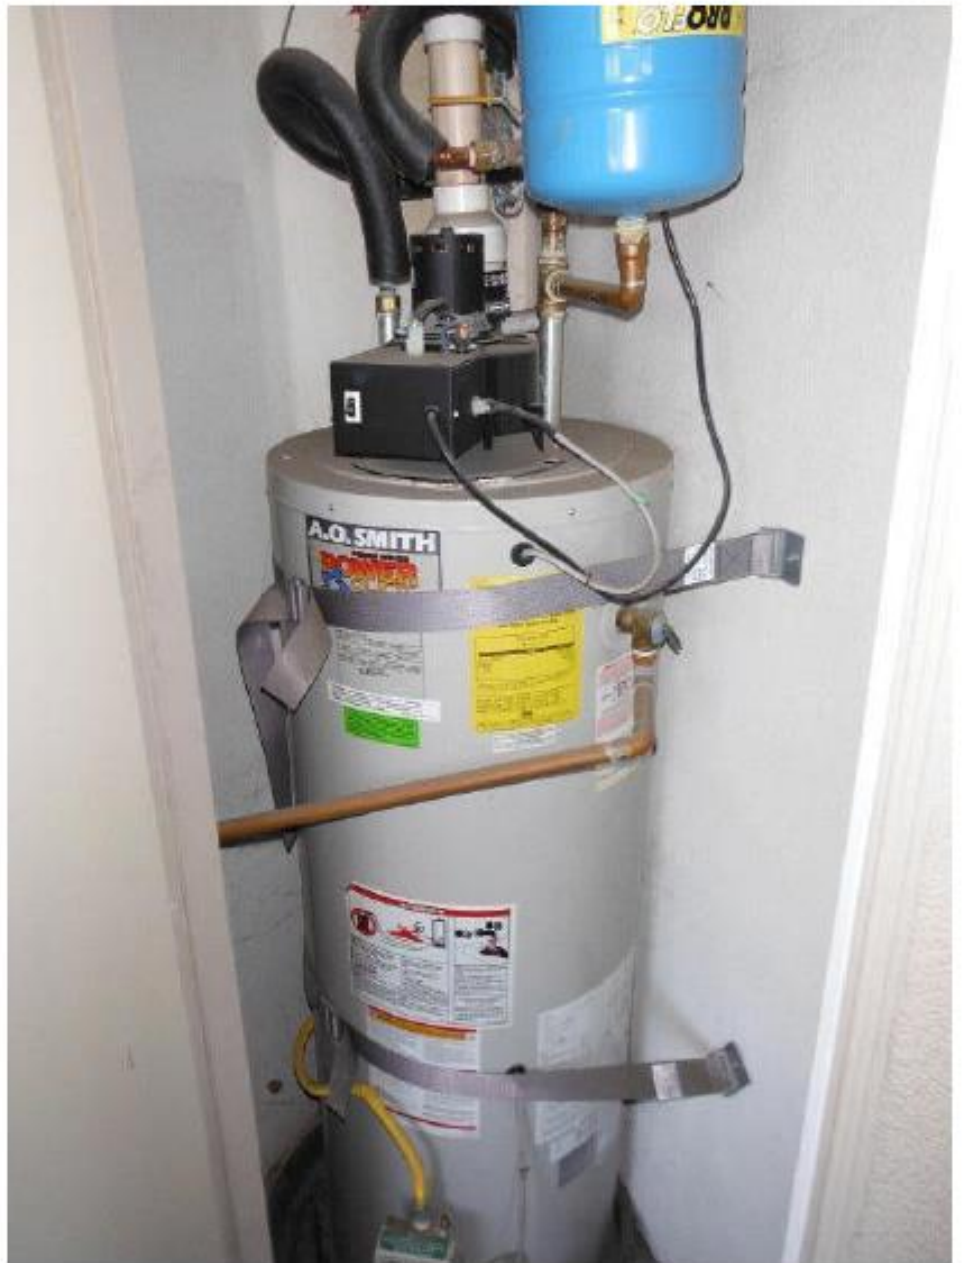
612 LOCATION(S)

The water heater was located in an exterior closet on the patio.

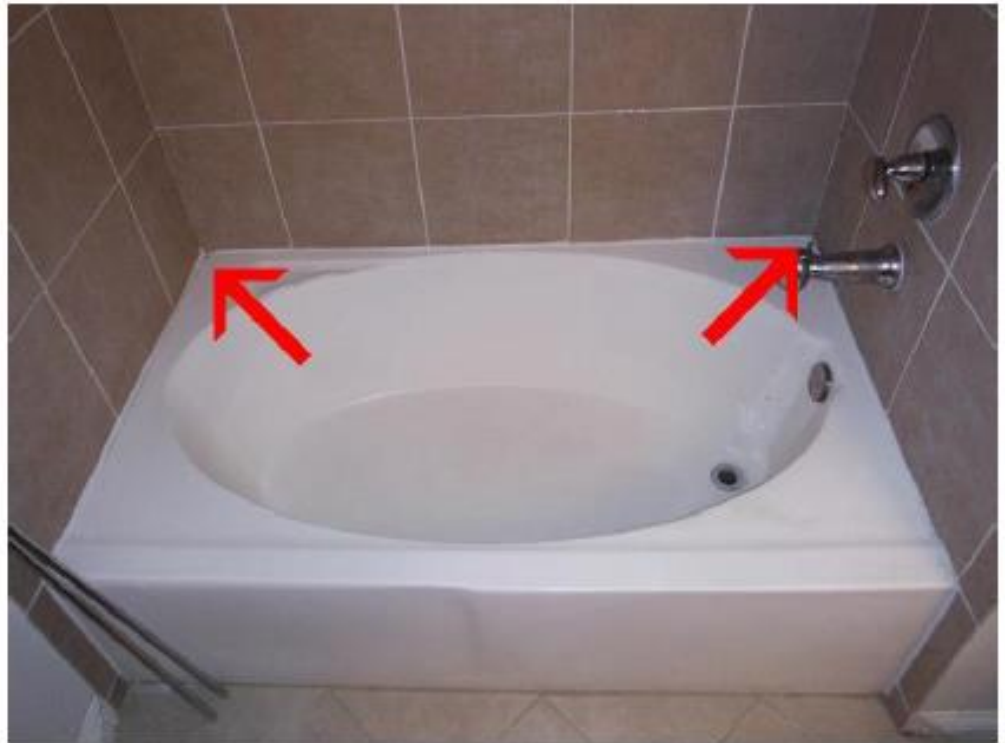
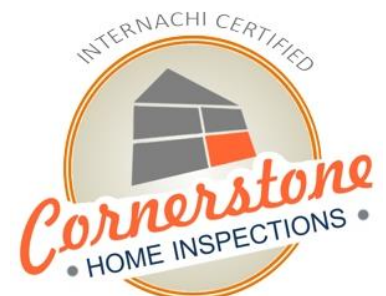
633 TUB(S)/SHOWER(S)

[CR] The grout/caulking in the master bathroom tub/shower was cracked or missing. We recommend correcting this condition to prevent moisture intrusion into concealed spaces.
